RAILROAD ACCIDENT REPORT

HEAD-ON COLLISION OF
BURLINGTON NORTHERN
RAILROAD COMPANY FREIGHT TRAINS
EXTRA 6311 WEST AND
EXTRA 6575 EAST
NEAR WESTMINSTER, COLORADO
AUGUST 2, 1985

NTSB/RAR-86/02

Adopted: June 20, 1986

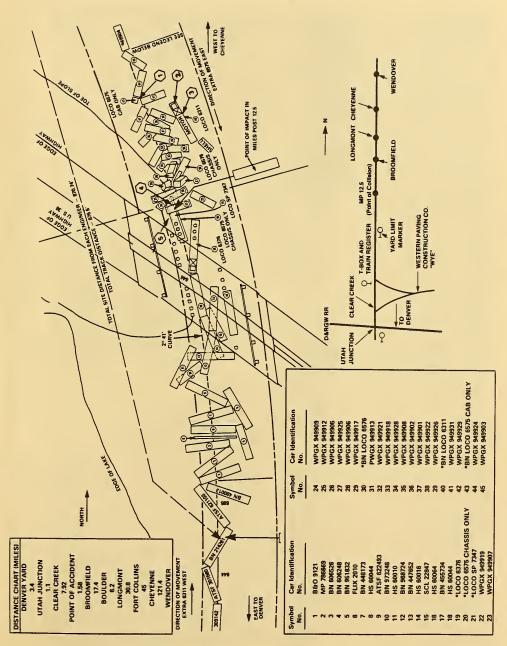
Figure 1.--Plan view of derailment.

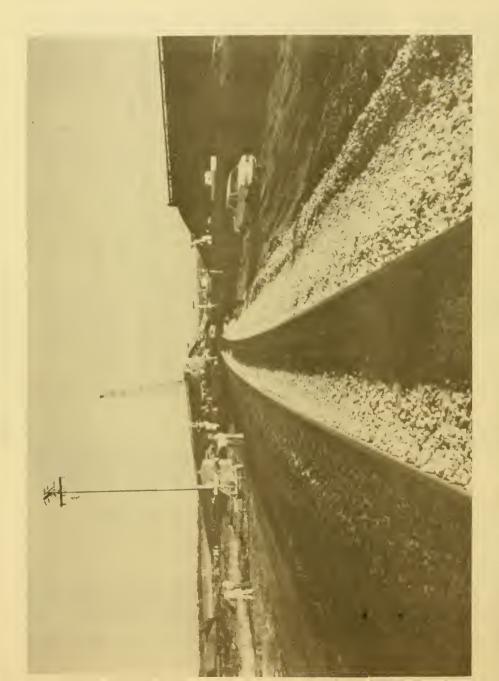
Figure 2.--Approach view eastbound of curve at MP 12.5 for Extra 6575 East.

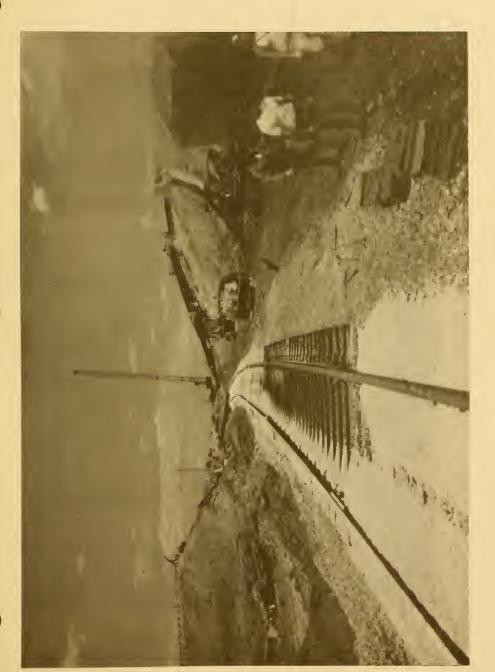
Figure 3.--Approach view to curve at MP 12.5 for Extra 6311 West.

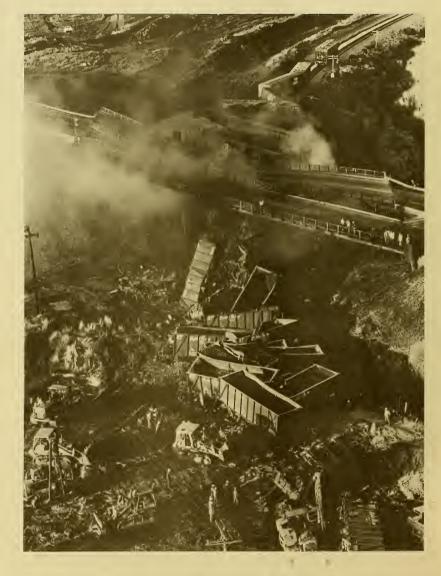
The three locomotive units of Extra 6311 West and the two locomotive units of Extra 6575 East were destroyed because of structural damage from the collision and the ensuing fire. Also 38 freight cars were destroyed. The impact forces of the derailing/piling cars against the highway bridge support members and the heat from the fire caused the bridge to buckle and distort to partial destruction so that it had to be torn out and rebuilt. (See figures 4 and 5.) About 900 feet of the main track were destroyed.

Figure 4.--Wreckage looking east.

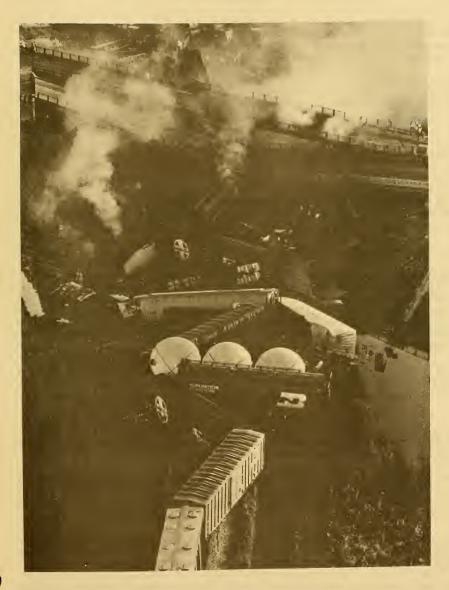
Figure 5.--Wreckage looking west.

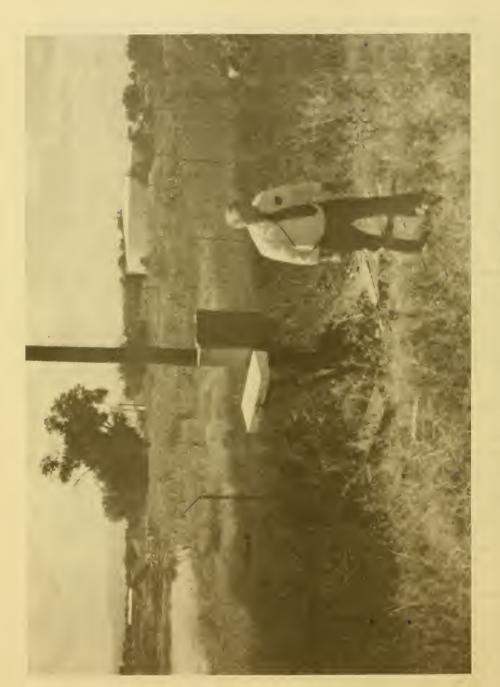
Figure 7.--Train register box and T-box at Clear Creek.

When one of the crewmembers on the locomotive of Extra 6311 West checked the train register at Clear Creek, he failed to perceive that the information recorded in the train register book was about Extra 6575 East of August 1. As a result of his misperception, he provided the other crewmembers with the incorrect information about Extra 6575 East. There were no surviving witnesses who could testify that they saw the crewmember unlock the register box, remove the train register book, and read the entries. The train was standing between the witness in the Western River Paving Construction Company so the witness' vision was blocked. However, since the 4:40 p.m. time quoted by a crewmember in the radio report to the conductor is a factual entry of record, the Safety Board concludes the train register book was removed from its repository and viewed by a crewmember. Since it is not known for certain who read the train register, the Safety Board could not determine the circumstances surrounding the dissemination of incorrect train register information. Although the tape recording of the radio message from the crewmember on the locomotive was not of good quality, probably because of the distance between Clear Creek and the Longmont radio base station, the reception of the message on the caboose by the conductor would have been more easily understood.
